Update on Galvanized Reinforcing Bar for Concrete: Process, Life Prediction and Application Developments

**By Frank E. Goodwin
International Zinc Association**

**For Presentation at
Asia Pacific General Galvanizing Conference**

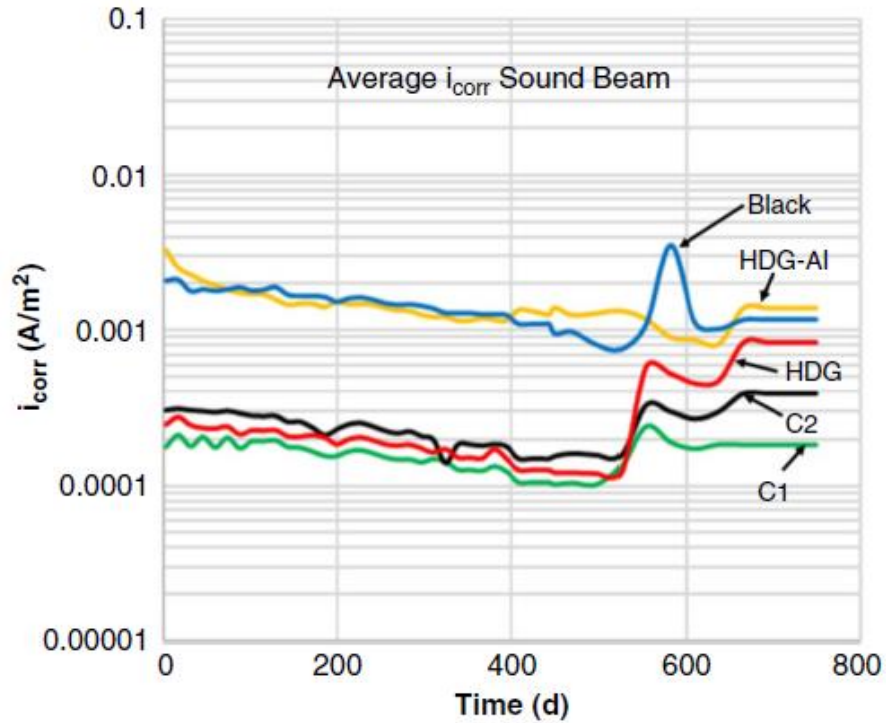
Figure 1. Average values of the corrosion current densities of five replicate specimens of CGR (C1,C2), general galvanized (HDG to ASTM A767 and HDG-7%Al) and black rebar exposed in sound (non-cracked) concrete over a 2.1 year exposure time to Ontario multichloride deicing solution (Reference 2).

The harsh Canadian winter climate requires the use of more concentrated de-icing salt to keep roadways clear in comparison with other locations. Typical Ontario brine consists of 16% CaCl_2 + 12% NaCl + 4% MgCl_2 , giving a Cl content of 21%. In many other localities, Cl concentrations around 3% are used. To determine the performance of general galvanized, continuous galvanized and black rebar under simulated Canadian conditions, a set of concrete slabs containing these types of rebars were cast, cured for 40 days and exposed to this chloride brine for 64 weeks.² These were then assessed using the galvano-static pulse technique with a current pulse of 10 mA for 200s, checking the corrosion current and corrosion potential twice a week. Both sound and pre-cracked samples were used. Two varieties of pre-cracked samples were studied, those with cracks parallel to the rebar (longitudinal cracks) and those where the cracks were positioned across the width of the sample (transverse cracks), with the pre-crack always extending to the surface of the embedded rebar. After breaking the samples apart, no active corrosion was seen in either of the galvanized or black rebar in the initially sound blocks. On the other hand, in all of the pre-cracked concrete blocks, corrosion always started at the base of the crack and extended along or around the bars. Rebar samples tested included two early-stage continuous galvanized rebar samples, a conventional hot dip galvanized rebar sample and a hot dip rebar with an experimental Zn-Al coating. The two CGR coatings had specified coating thicknesses of 50 μm but in fact were received with thinner coatings averaging 41 μm for sample C1 and 33 μm for sample C2, whereas the Al-containing coating HDG-Al was specified as 30 μm thick but exhibited an average thickness of 26 μm . The CGR1 and CGR2 samples were produced during early stage trials in China and shipped to Canada. They were not passivated at the time of manufacture, but the time between the June 2014 production of the samples in China and February 2015 casting of research samples, including ocean freight from China to Canada, was sufficient to permit forming of the customary basic zinc carbonate passive layer. By contrast, the HDG-Al samples were produced by stripping the coating from several CGR sample received from China and re-galvanizing them in Zn-7%Al bath during January 2015, after which they were used with the C1 and C2 rebar for preparing samples. The 150 μm average thickness general galvanized coating termed HDG was in conformance with ASTM A767 and was passivated with a chromate treatment at the time of manufacture. A conventional mild steel was used for the black rebar comparison. The corrosion current measured for each of these samples with time for the uncracked samples is shown in Figure 1. It can be seen that the HDG and the two CGR samples had corrosion currents lower than $.0003 \text{ A/m}^2$. These were relatively stable until about 550 days, after which active corrosion appeared to begin. At this point the HDG sample corrosion current increased the most rapidly of the coated samples, which is usually indicative of the start of corrosion of the Fe-Zn intermetallic. By contrast, the two CGR samples increased less and then corroded at lower rates than the HDG. By contrast, the HDG-Al sample and the black bar behaved in a similar manner, with an initial corrosion current of around 0.002 A/m^2 . These also proceeded to about 550 days, after which the black rebar

began corroding more rapidly before again decreasing, but still showing a higher corrosion current than the HDG and CGR samples, and about the same as the HDG-Al bar. Related work, conducted under comparable conditions, showed that after 450 days exposure, the microcomposite low-Cr steel, MMFX-2, was exhibiting active corrosion.³ The equivalent corrosion rate for the HDG and CGR samples in Figure 1 is 0.1 $\mu\text{m}/\text{y}$ (corresponding to 0.0001 A/m^2) whereas the MMFX-2 was corroding at an order of magnitude higher rate, 0.001 amperes per square meter, or 1 $\mu\text{m}/\text{y}$. This is about the same magnitude as observed in Figure 1 for the black bar and the HDG-Al bar. From a durability point of view, the maximum acceptable corrosion current for rebar embedded in concrete is 0.001 A/m^2 .

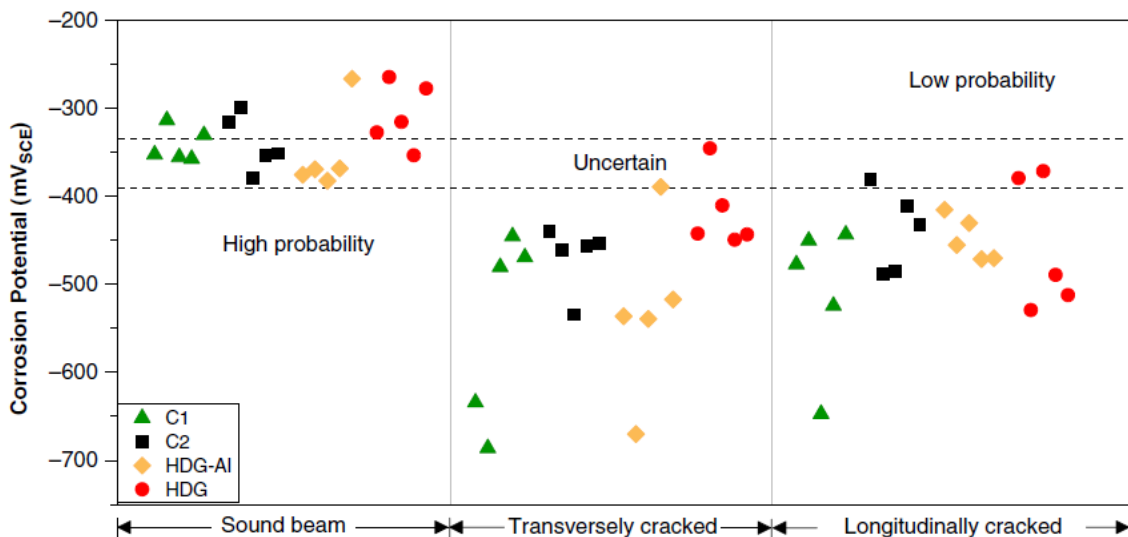
Figure 2. Potential guideline for assessing the probability of corrosion of galvanized steels in concrete. Each point represents a potential value at the end of 64 week exposure to Ontario multichloride deicing solution (Reference 2).

The corrosion potentials of the rebars examined in Reference 2 are shown in Figure 2. These cannot be interpreted to understand their corrosion status with the customary ASTM C876 recommended potential values. For black bars, these are that when the measured potential is more positive than -125mV SCE there is a 90% probability of passive corrosion; when it is more negative than -275mV SCE there is a 90% probability of active corrosion. The situation with corroding Zn is very different because the initial active corrosion potential of Zn is -1100mV SCE; however, this becomes much more positive (anodic) as the CHZ layer is formed, bringing it up to about -300mV SCE. As explained in Reference 2, when Cl levels next to the rebar reach the point so that zinc corrosion begins, this exposes the Fe-Zn intermetallic layer and then the underlying steel and therefore the potential then decreases again into between -400mV and -680mV. Therefore, Reference 2 concluded that new corrosion thresholds should be used to judge the performance of galvanized rebar in concrete. These are shown by the dotted lines in Figure 2; i.e., for a potential more positive than -335mV SCE there is low probability of corrosion and for a potential more negative than -385mV SCE a high probability of corrosion with an uncertain region existing between these potentials, following the methodology of ASTM C876. This follows the same general direction as guidelines developed by the National Research Council of Canada,⁴ which also suggests that more negative millivoltages be used to judge the behavior of Zn-coated rebar in concrete versus black rebar.

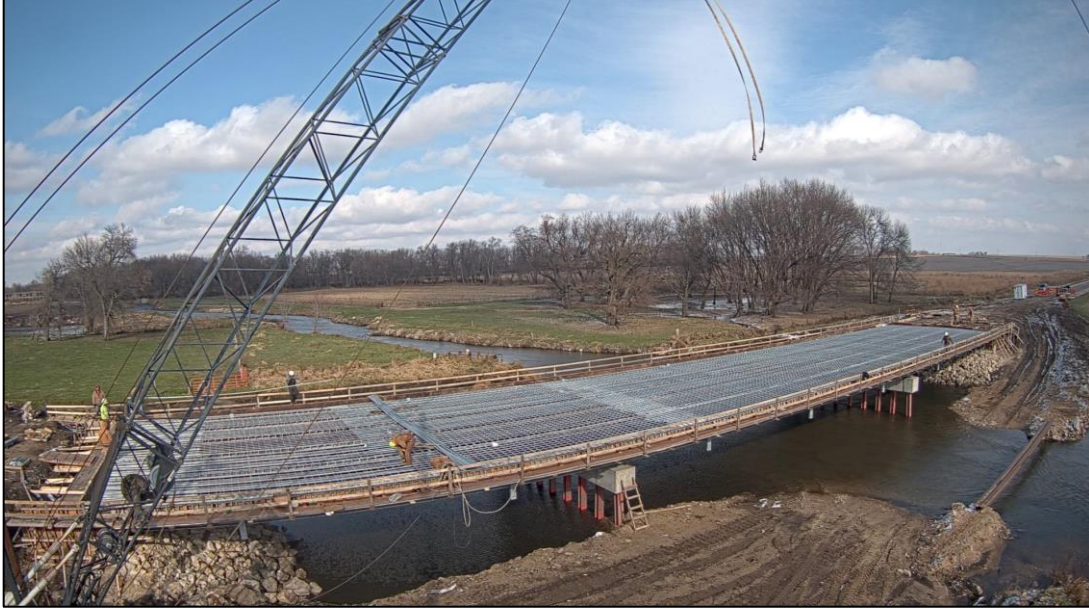
Figure 5. First bridge constructed with CGR, using 75 tons: Buffalo Creek Bridge in Independence, Iowa, USA (Source: AZZ Metal Coatings)

The first bridge constructed with CGR spans Buffalo Creek in Independence, Iowa. It is a 2-lane, 18.6 m long composite bridge. General galvanized steel was used for the pilings, structural beams, guard rails and miscellaneous items, while the concrete abutments, parapets and bridge deck used 75 tons of CGR to reinforce the concrete. A picture of the bridge is shown in Figure 5. This bridge is in a rural area; closure of the bridge for replacement resulted in significant detours for local residents. The ability to bring CGR to the site and bend it on site to exactly the required shapes saved construction time and in addition it was competitively priced.

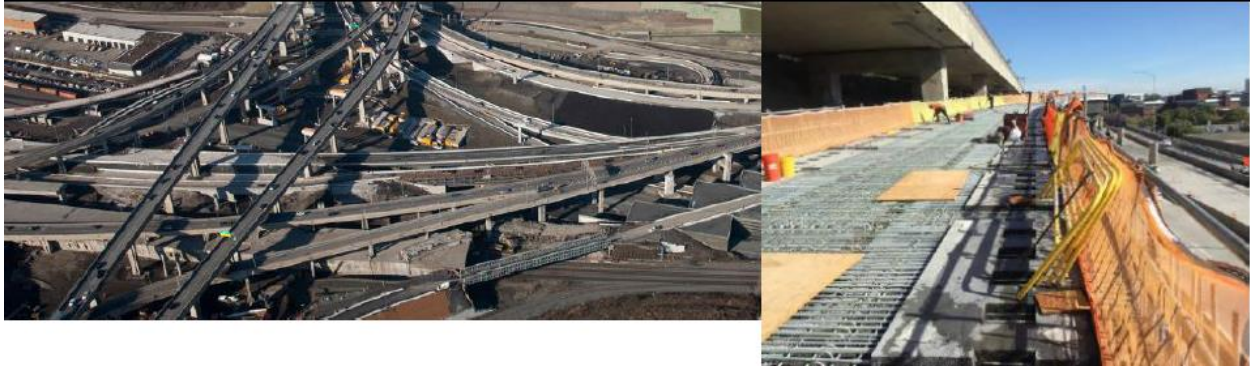
Figure 7. The Turcot Interchange reconstruction project on the southwest side of Montreal. Decks and abutments are made from both precast and cast-in-place concrete reinforced with galvanized rebar.

The Turcot Interchange is a three-level stack freeway interchange, and the largest in the province of Québec. Originally completed in time for the 1967 Montreal Expo, it has seen even heavier doses of deicing salt than that used on the New York Thruway, and has required constant repair over the years. A complete reconstruction began in 2012, with the expected project completion date of July 1, 2019. To speed construction and reduce cost, many of the roadway decks for overpasses using galvanized rebar are precast in a nearby factory, which also allows for temperature regulation, thus improving quality. The use of precast slabs allows for faster construction, resulting in cost savings. The retaining walls, certified also for use as for overpass abutments, are also usually made from precast forms. This project is using 15,000 tons of galvanized rebar; views of this project are shown in Figure 7.
